**Design and Construction Consulting Services for
White Mountains Community College
LITTLETON CAMPUS RENOVATION AND EXPANSION at
646 Union Street, Littleton, NH
Project # WMC21-01**

Appendix A: WMCC Littleton Existing Building Assessment

Appendix B: WMCC Littleton Conceptual Programming and Design Study

**Design and Construction Consulting Services for
LITTLETON CAMPUS RENOVATION AND EXPANSION
At White Mountains Community College, Littleton, NH
Project # WMC21-01**

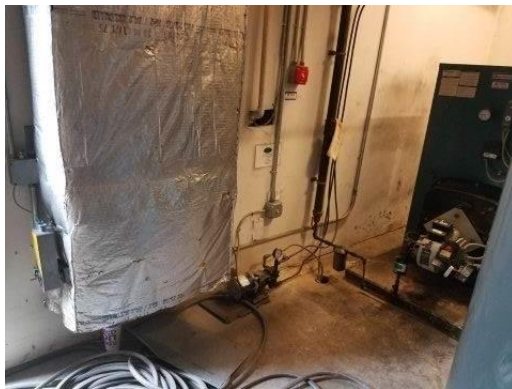
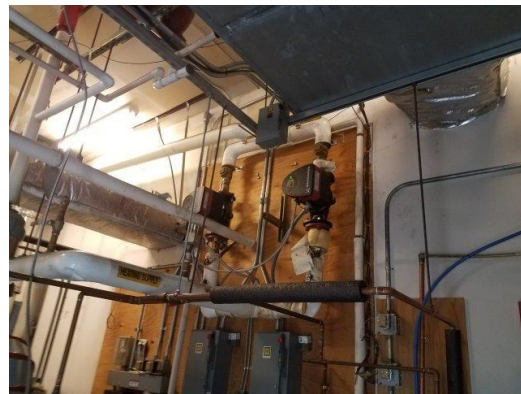
1. The subject facility is heated by two (2) oil fired Burnham model V905A sectional cast iron boilers each rated for 562,000 Btuh net capacity. Fuel oil that serves the boilers is stored in an old single wall steel construction 1,000 gallon capacity underground tank located immediately outside of the boiler room. Condition of the existing tank is unknown, and certainly warrants inspection and possible replacement as part of any property purchase plan.

A relatively new fuel oil transfer pump housed in the boiler room feeds oil to the two (2) boilers and a domestic water heater. The two (2) boilers are sized to provide essentially 66% redundancy and are programmed for lead/lag/automatic alternation operation. Hot water generated by the boiler plant is circulated by means of relatively new variable speed inline pumps programmed for lead/lag/automatic alternation operation. The heating hot water system is automatically reset in response to outside air temperature through a dedicated boiler plant digital controller. Hydronic heating terminals serving the building include fin-tube radiation, cabinet heaters, ducted heating coils and air handling unit hot water coils, all fit-up with digital control valves.

Fuel oil consumption for fiscal years 2019 and 2020 average 7,147 gallons annually, or 0.28 gallons per square foot per year, which is surprising low considering the building's insulation shortcomings. However, we suspect that outside air introduced through the existing HVAC systems is minimal which would help to explain the rather conservative annual fuel consumption.

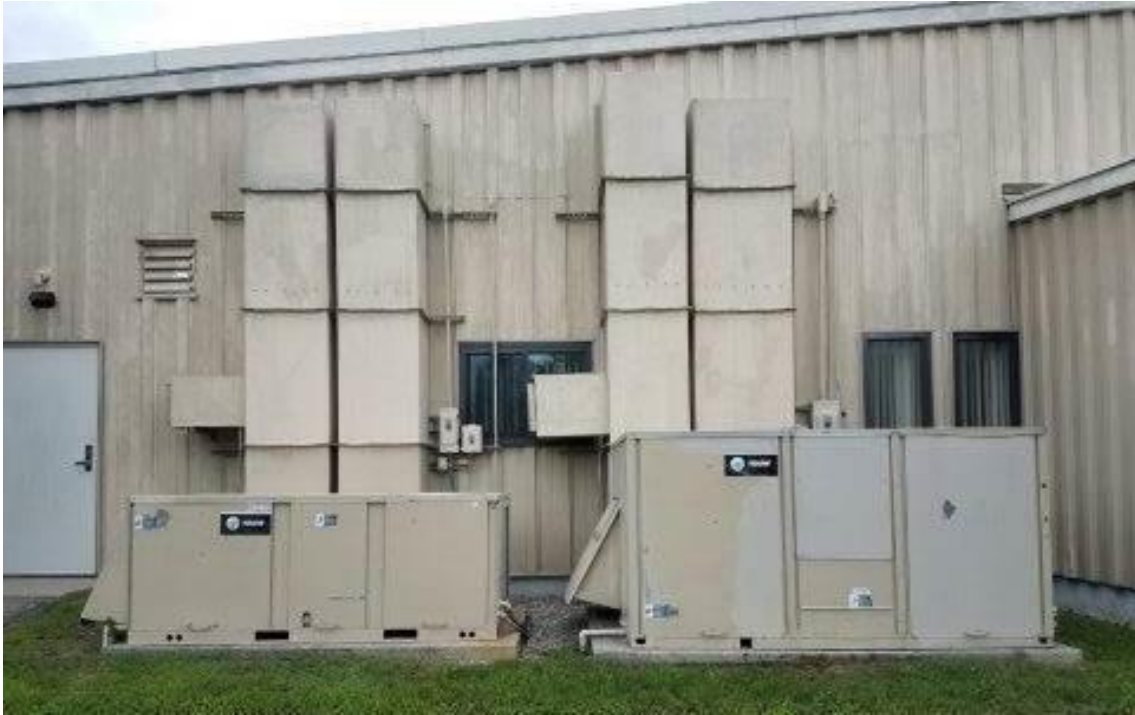
2. Ventilation for the facility is accomplished by six (6) packaged air conditioning units set on grade and three (3) indoor air handling units, along with a number of exhaust fans that extract air from toilet rooms, janitor closets and other miscellaneous spaces. Five of the six packaged air conditioning units are very old at this point and time and will likely need replacement within the next five years or so.

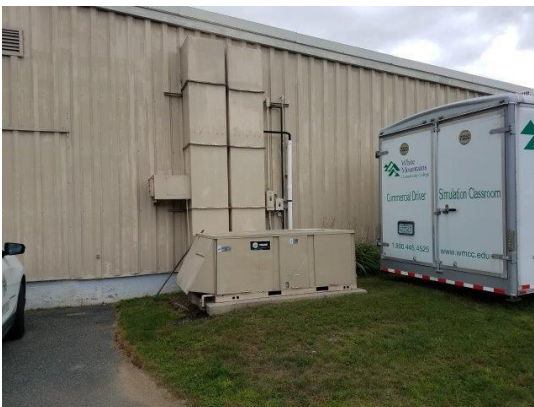
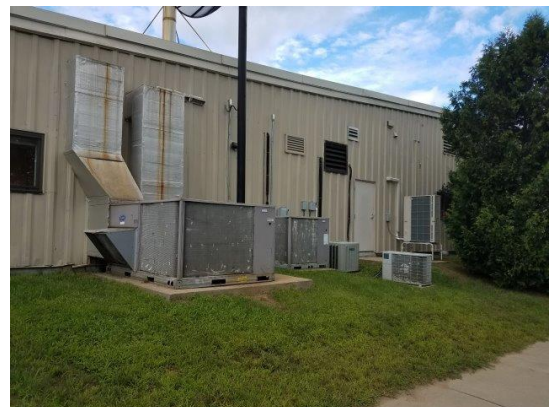
3. Air conditioning is provided to specific areas throughout the building by means of the packaged air conditioning units that reside on grade noted above, along with multiple ductless split air conditioning systems. The existing air conditioning systems for the most part utilize R-22 refrigerant which is being phased out of production due to environmental impact. As mentioned previously, several of the air conditioning systems are nearing the end of rated service life and replacement cost should be factored into any property purchase plan.

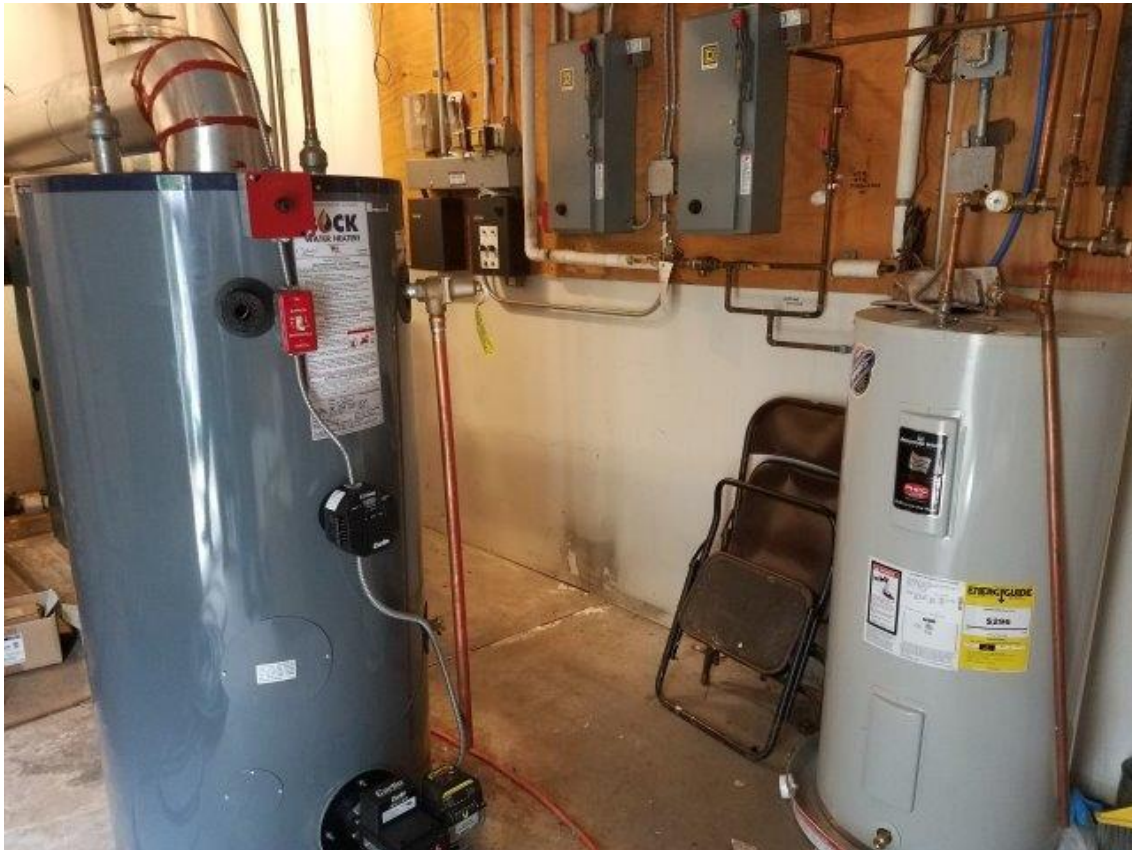
1. The existing sanitary drainage waste and vent system is in good condition and should prove relatively simple to rework to accommodate building renovations.
2. Both water and sewer connect to municipal services.
3. Plumbing fixtures are aged in some cases, but in good and operating condition throughout the facility.
4. The domestic hot water generation plants are in good condition.

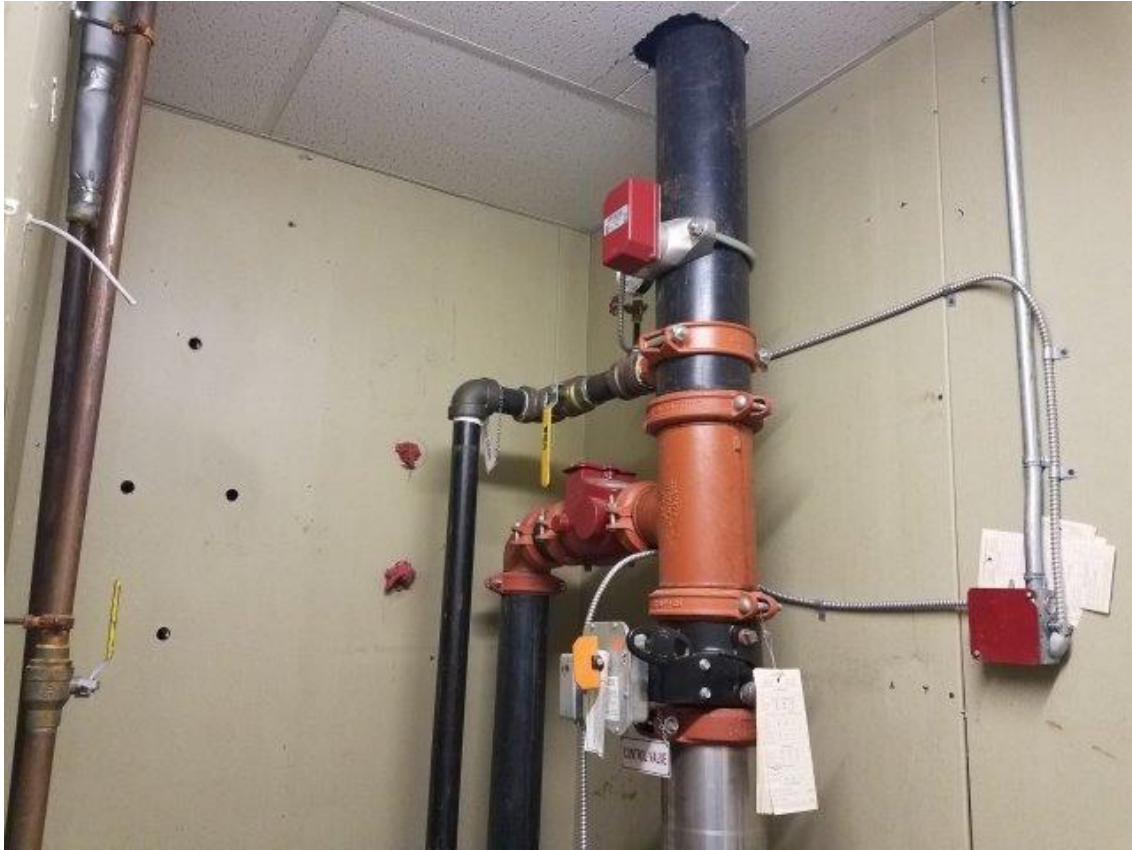
1. The entire facility is protected by a NFPA-13 compliant automatic sprinkler system that appears to be in good condition and is regularly serviced, maintained and tested.

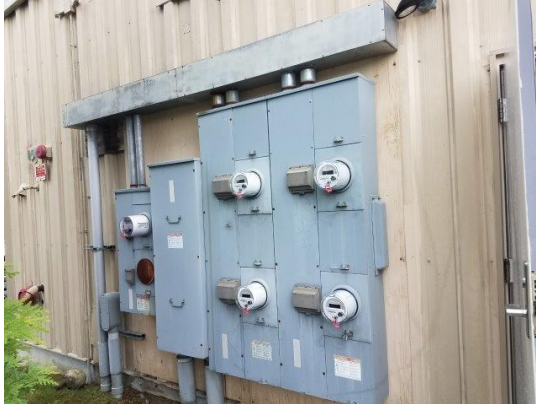
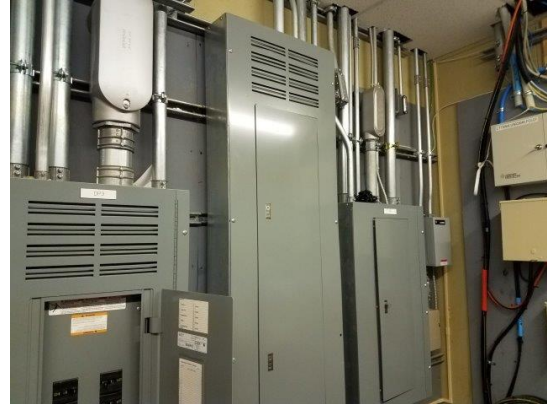
1. The existing electrical service is an 800 (+/-) ampere, 120/208V, three phase, four wire main service. Individual utility meters serve main circuit breaker panels that feed multiple panelboards throughout the facility. The switchgear is manufactured by Square D.

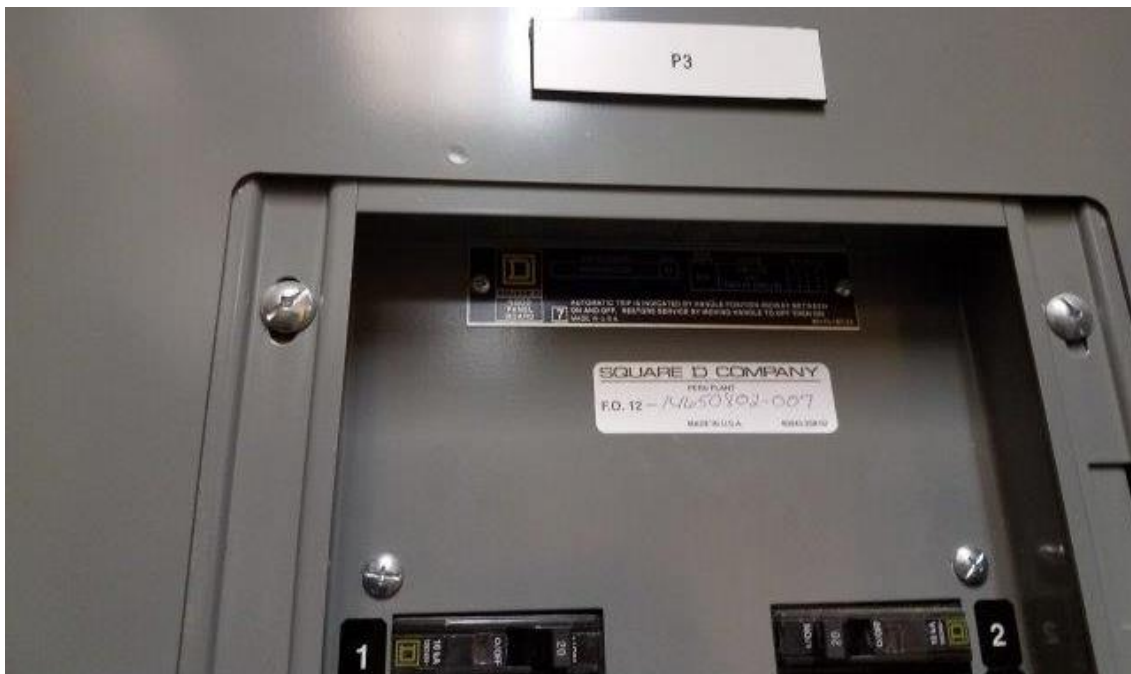
1. Panelboards are installed throughout the facility with many being original and others added over the years to accommodate tenant spaces. Panelboards amperage ratings vary, but are 120/208V, three phase, four wire. The panels appear to be in good shape and in some cases candidates for expansion as extra circuit breakers are available. The panels are labeled with typed directory cards and in some cases have spare capacity available for future circuits.

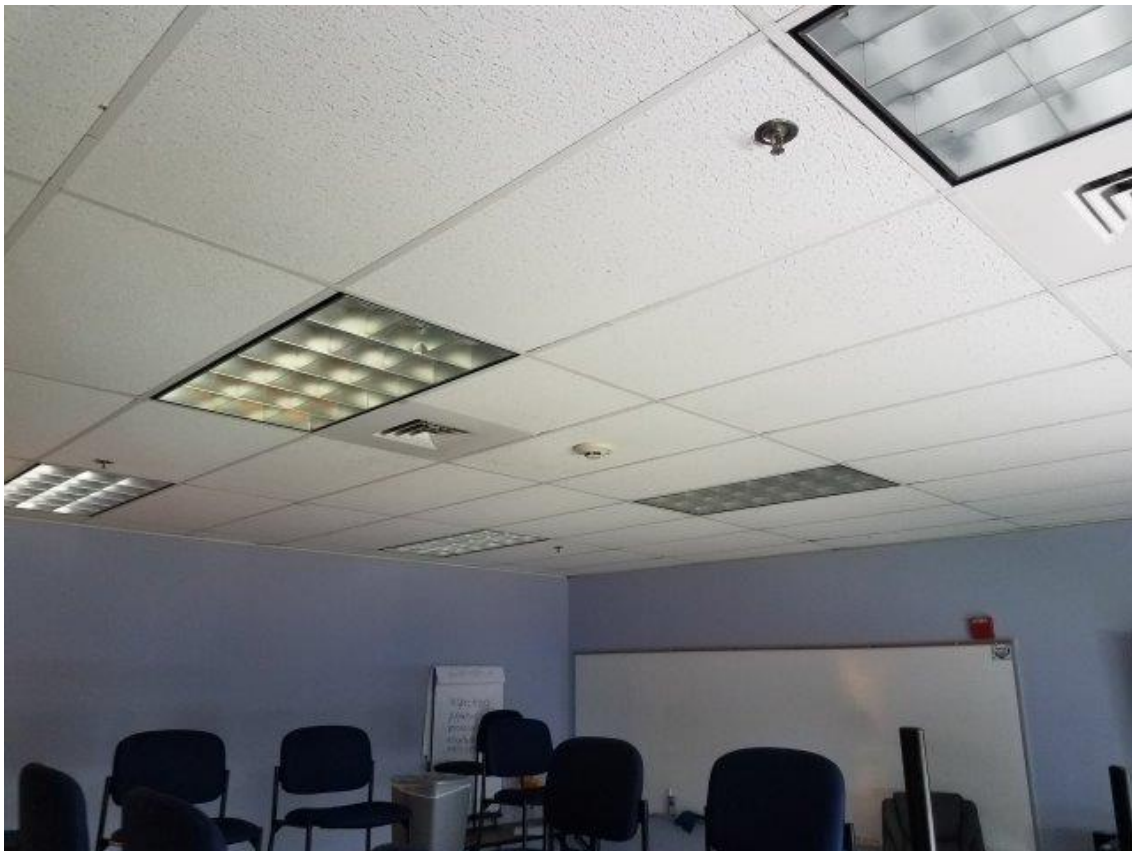
1. Existing interior lighting systems are a mixture of recessed and surface mounted fluorescent and LED lighting fixtures. The majority of the fixtures are provided with 4' fluorescent T8 lamps. Some surface mounted fixtures have replacement lamps installed. The existing lighting may be maintained, but replacement and new lighting fixtures should be LED type.

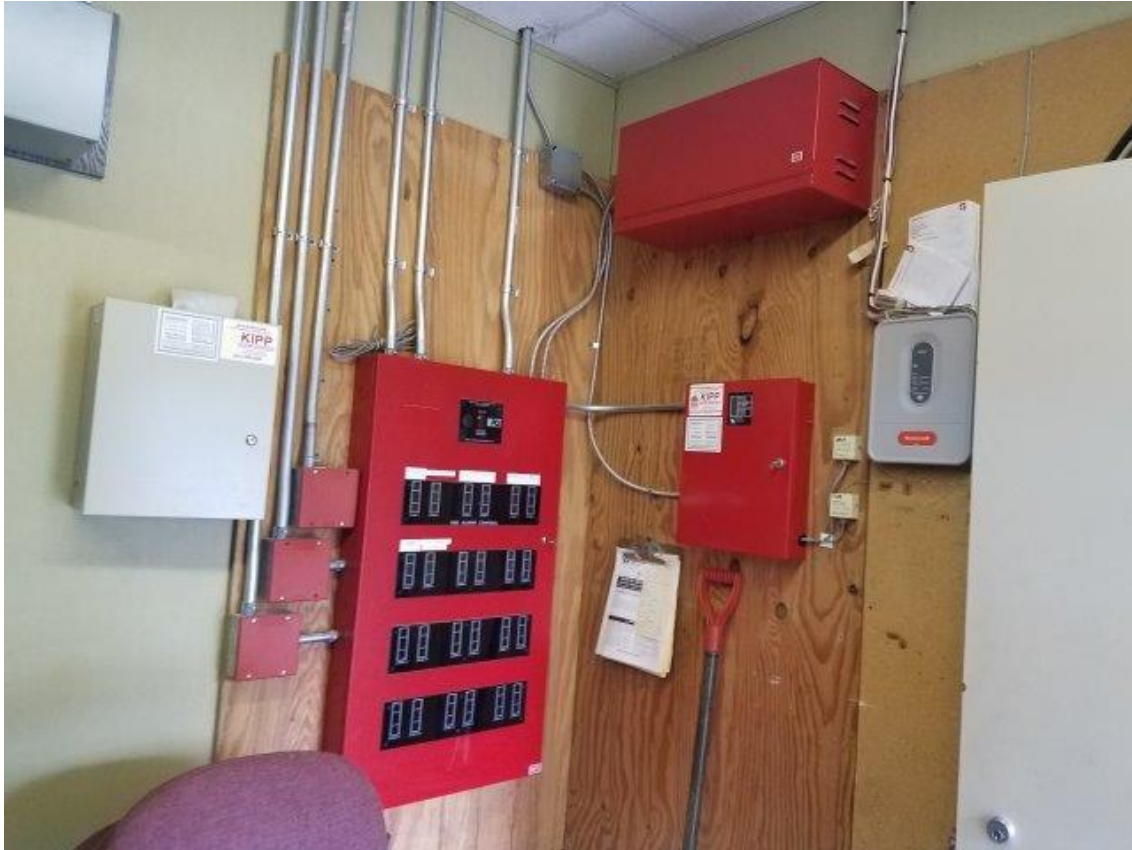
1. The existing panel fire alarm system is a conventional zone type. The panel is aged at this point and should be reviewed by a licensed fire alarm installer to assess continued service.

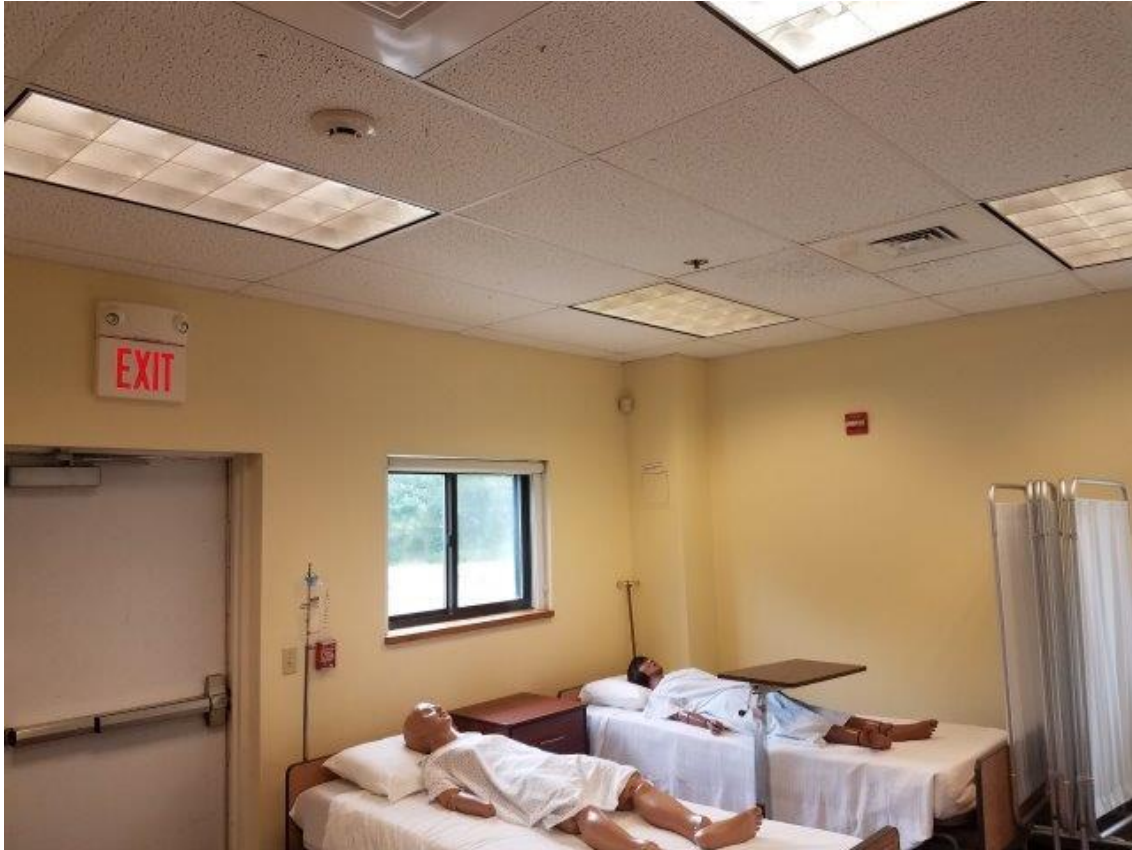
1. The emergency lighting is provided by self-contained emergency lighting products and exit signs with integral batteries and chargers, designed to provide 90 minutes of emergency illumination.
